RY ANALYSIS DIVISION		
over str	Rao Hwy. Bridge SE No. 1 eam o. 28 on NE 48-2	COUNTRY  North Vietnam	COORDINATES  19 17N - 104 26E  VG 402320	 25X1
MAP	AMS L509 NE 48-2		BRIEF NO: PIB 75001 July 1966	 25X1
LOCATION:	0.5 nm S of Cua Rao on Ro	ute 7.		
LENGTH WIDTH Type	Deck	MATERIAL Concrete NO. OF SPANS 3 probe	able	25X1 25X1

CIA IA	MAGERY ANALYSIS DIVISION		<del></del>
NAME		COUNTRY	COORDINATES	
Phuong Hoang Hwy. Bridge No. 66 on 1		North Vietnam	18 13N - 106 04E XF 136146	
			BRIEF NO: PIB 75002	 25X
MAP AMS L50	9 NE 48-7		<b>T</b> July 1966	
LOCATION: 0.5 nm	N of Phuong Ho	ang on Route 1A.

CIA IMAGE	RY ANALYSIS DIVISION		
NAME Quang Te RR. Bridge over Khe Hac Giang Bridge No. 30 on NE 48-7	COUNTRY  North Vietnam	COORDINATES  18 27N - 105 34E  WF 609405	 25X1 
MAP AMS L509 NE 48-7		BRIEF NO: PIB 75003 July 1966	25X1

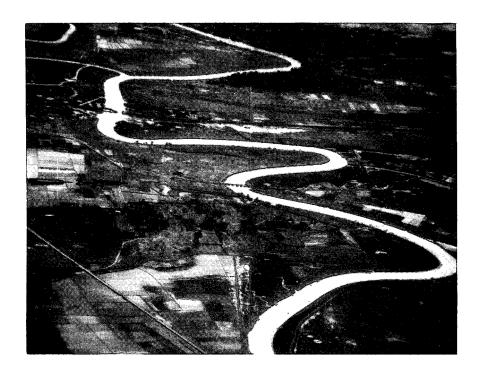
Repaired and serviceable.

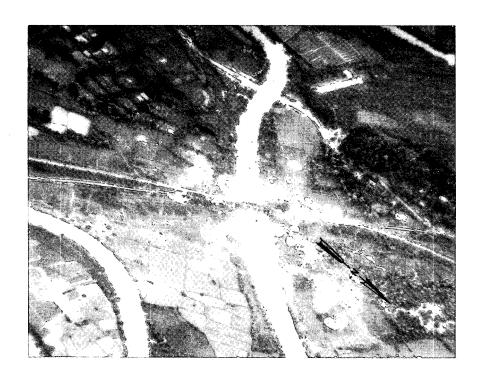
Both spans heavily damaged and twisted.

By-pass bridge now serviceable.

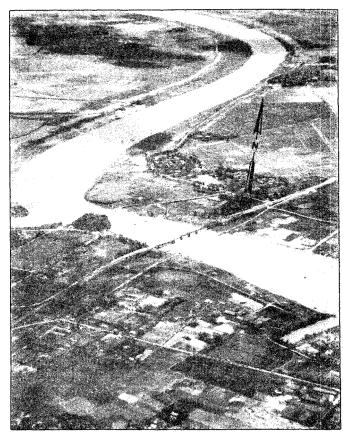
Southernmost through-truss destroyed and swing-span damaged.

Swing-span repaired and truss replaced by deck with timber supports for rail traffic only. Railroad bridge by-pass under construction west of present bridge.

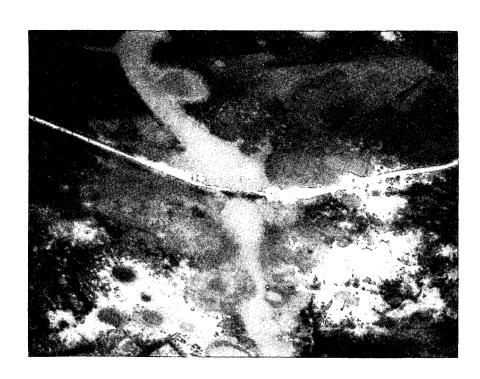
2 spans dropped; 1 severely damaged.

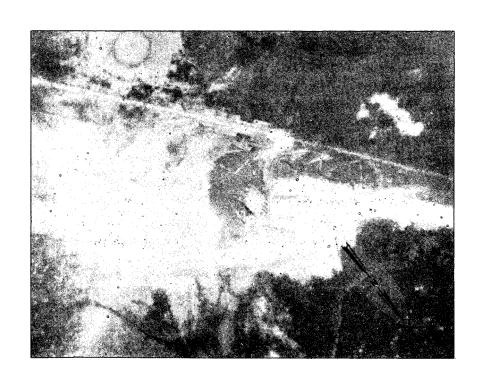
Spans and piers destroyed.

Ford

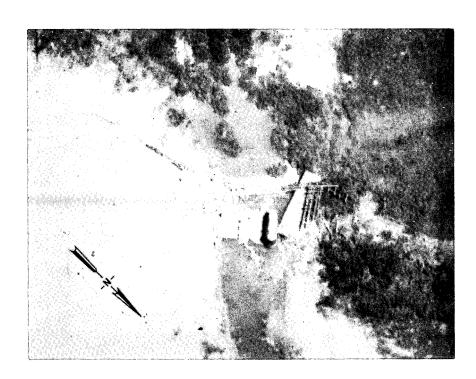
Both spans destroyed; 1 pier, 1 abutment intact.

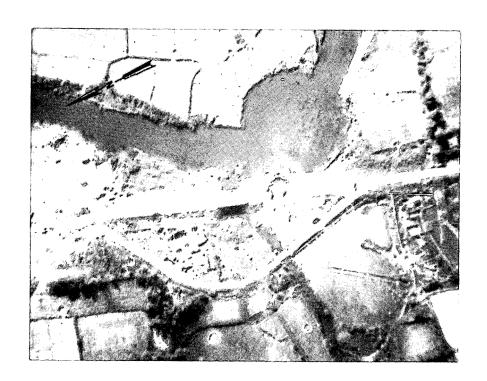
The destroyed 160' truss span has been replaced by steel cables and probable removable decking. Abutment is repaired. Bridge probably serviceable.

Ford 400' N of bridge.

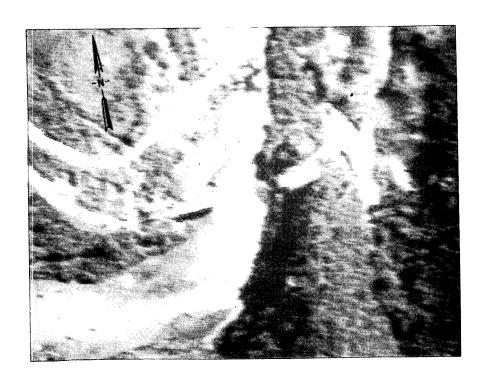
CIA IMAGE	RY ANALYSIS DIVISION		<del></del>
NAME Coi Khe Hwy. Bridge over	COUNTRY	COORDINATES	
Song Len Trib  Bridge No. 8 on NE 48-3	North Vietnam	19 59N - 105 55E WH 969096	25X1
bridge No. 0 on NE 40-3	North Vietnam	WIL 909090	OEV4
		PIB 75099	25X1
MAP JOG (A) 1501 NE 48-3		August 1966	
LOCATION: 0.6 nm NW of Giai Uan on un  DESCRIPTION: LENGTH	numbered route.		
WIDTH	NO. OF SPANS 11 prob	pable	25X1
Deck	LENGTH OF EACH SPAN		25X1
status: 4 spans and 3 piers destroyed.

Ferry

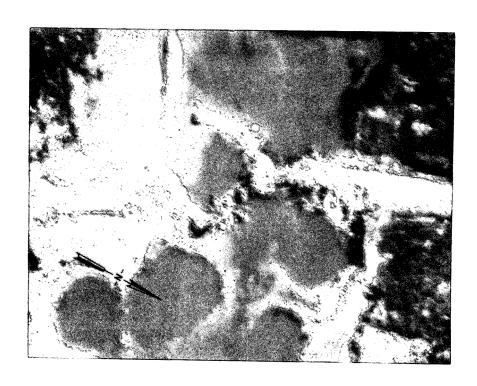
RY ANALYSIS DIVISION		
	Phuong Hwy. Bridge S over	COUNTRY	COORDINATES	_
Song Dir.		77	17 32N - 106 33E	25
Briage N	Io. 22 on NE 48-12	North Vietnam	XE 646406	
			BRIEF NO:	25
MAP	AMS JOG 1501 (A) NE 48-1	2	PIB 75123	
LOCATION:	0.3 nm S of Xom Phuong on		August 1966	
	o. J min b or nom indong on	noute in.		
DESCRIPTIO	N:			
LENGTH	110' approx.	MATERIAL Concrete		
WIDTH	10' approx.	NO. OF SPAN'S 11		
TYPE	Deck	LENGTH OF EACH SPAN 10	O' approx.	
TATUS:				_
	ginal bridge destroyed; rep		troyed,	2
tin	iber replacement span modera	tely damaged.		_
	IVE ACTION:			
COMPENSAT				
compensat For	.a

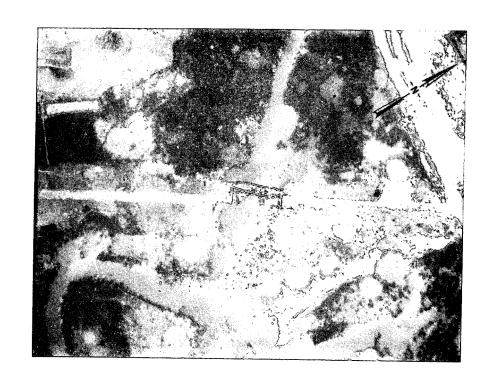
Span heavily damaged - out of alignment; bridge not serviceable.

None

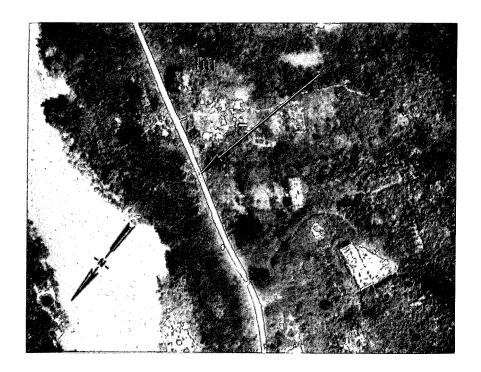
CIA I	MAGERY ANALYSIS DIVISION		<del></del>
NAME	COUNTRY	COORDINATES	
Ban Houei Ty Hwy. Bridge		19 23N - 104 10E	OEV4
Bridge No. 23 on NE 48-2	North Vietnam	VG 122442	25X1
		BRIEF NO:	
		PIB 75132	
MAP AMS L509 NE 48-2		August 1966

Destroyed span replaced; bridge is well camouflaged and serviceable.

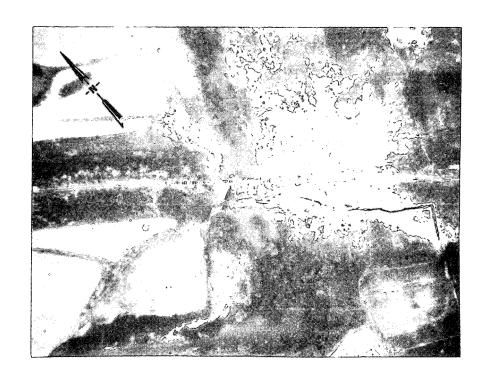
CIA IMAG	ERY ANALYSIS DIVISION		<del>_</del>
NAME Kim	Lu Xa RR. Bridge over	COUNTRY	COORDINATES	
Khe Dan	. 44 on NE 48-11	North Vietnam	17 57N - 105 57E XE 021848	25X1
MAP	AMS L509 NE 48-11		PIB 75139 August 1966	 25X1
LOCATION:	O.1 nm N of Kim Lu Xa o	n Vinh-Dong Hoi RR.	August 1900	_

Repaired and serviceable.

None

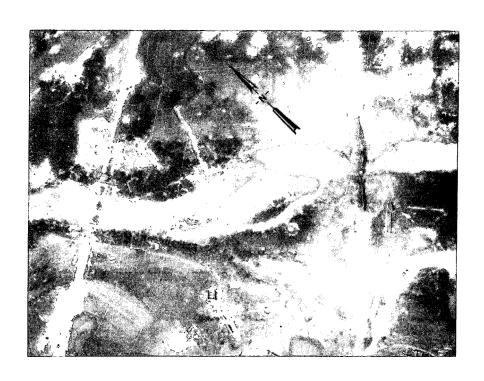
CIA IMA	GERY ANALYSIS DIVISION		
NAME Cao Nung RR. Bridge over	COUNTRY	COORDINATES	
Song Hoa		21 33N - 106 29E	2
Bridge No. 2 on NF 48-12	North Vietnam	XJ 554845	
		BRIEF NO:	<del>-</del> 2!
		PIB 75140	
	48 <b>-</b> 12	August 1966	_
LOCATION: 0.4 nm SE of Cao Nung	on the Hanoi-Dong Dang	Rail Line.	
DESCRIPTION:			
LENGTH 175' approx.	MATERIAL Steel.	concrete, and timber	
нтан	NO. OF SPANS	· · · · · · · · · · · · · · · · · · ·	2
Deck	LENGTH OF EACH SPAN	1 @ 70' approx., 1 @ 60'	apr
		1 @ 45' approx.	- 1 1
TATUS:		±±	
2 spans dropped (45' and 60'	'); l span heavily dama	aged (70'); by-pass	
bridge dismantled.			
OMPENSATIVE ACTION:			
77			
None			
			2

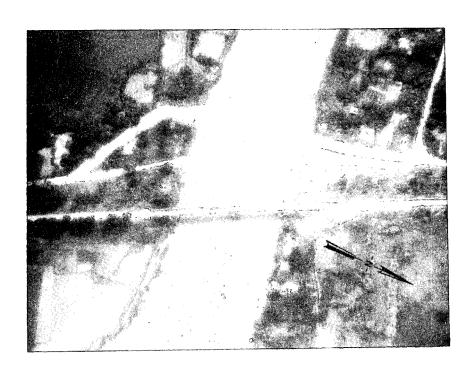
Repaired and serviceable.

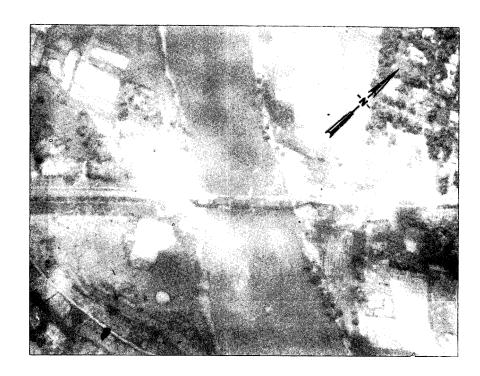
Two spans damaged/destroyed, one approach interdicted.

Affected spans repaired/replaced. Bridge is now serviceable. Approach remains interdicted.

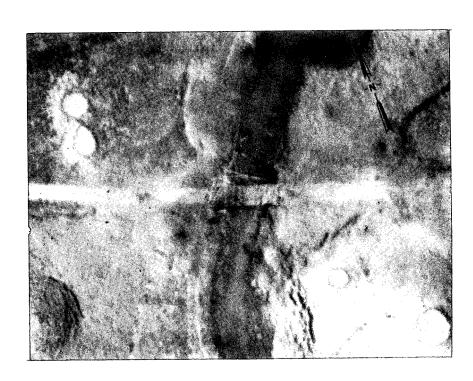
Moderate damage to deck.

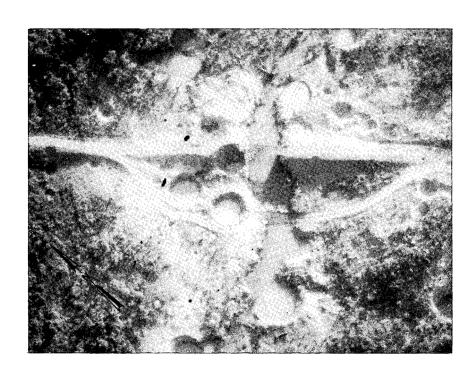
CIA IMA	GERY ANALYSIS DIVISION	
Than Dau Hwy. Bridge SE over	COUNTRY	COORDINATES
Khe Luy		18 00N - 106 28E
Bridge No. 96 on NE 48-7	North Vietnam	XE 916550
		BRIEF NO:
TO 0. / A \ D. 150 T		PIB 75186
MAP JOG (A) 1501 NE 48-7  OCATION: 1 nm SE of Than Day on F		September 1966
-ocation: 1 nm SE of Than Dau on F	toute LA.	
ESCRIPTION:		
LENGTH 40' approx.	material Wood	
WIDTH TO SEPONDE	NO. OF SPANS ]	
Deck	LENGTH OF EACH SPAN	40' approx.
TATUS:		
Span damaged moderately; one	e abutment damaged; one	e approach interdicted.
OMPENSATIVE ACTION:		
Ford		
Ford		
Ford

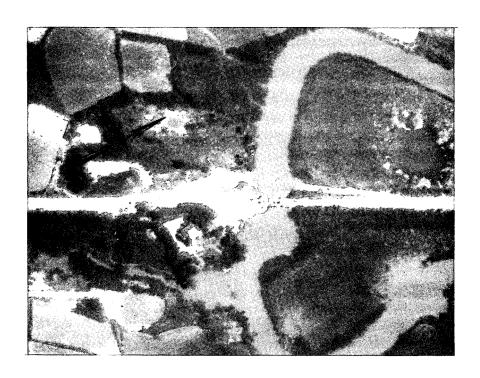
CIA IMAGEI	RY ANALYSIS DIVISION		<del></del>
NAME Tam Xuan Thuong Hwy. Bridge over Song Giang Bridge No. 93 on NE 48-7	COUNTRY  North Vietnam	COORDINATES   18 37N - 105 43E   WF 734550	 25X1
MAP JOG (A) 1501 NE 48-7 LOCATION: 1.0 nm S of Tam Xuan Thuon	g on Route 1A.	BRIEF NO: PIB 75195 September 1966	25X1 _
DESCRIPTION:  LENGTH WIDTH TYPE  Deck	material Wood  No. of spans 4 probabl  LENGTH OF EACH SPAN	Le	25X1
STATUS: Bridge is almost completely rep	paired; decking partial	Lly laid.	25X1
COMPENSATIVE ACTION: Ford			
			25X1

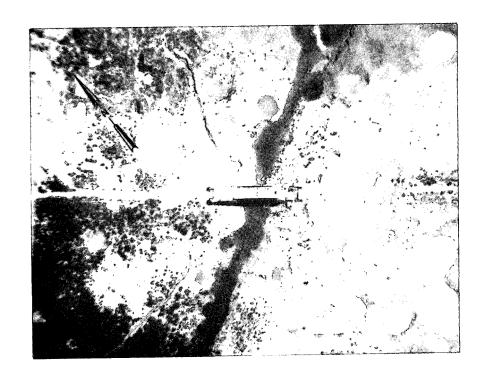
North approach and span repaired; south approach and span severely damaged. Bridge probably being rebuilt for rail service.

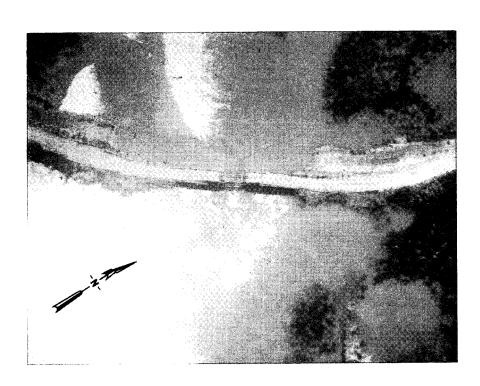
CIA IMAG	ERY ANALYSIS DIVISION		
NAME Tam Xuan Hwv. Bridge over	COUNTRY	COORDINATES	— 25
Song Giang Bridge No. 98 on NE 48-7	North Vietnam	18 37N - 105 42E WF 749588	25
bridge No. 90 on NE 40-1	NOT OIL VIE GLAIN	BRIEF NO:	<del></del> 25
		PIB 75199	
MAP JOG (A) 1501 NE 48-7		October 1966	
LOCATION: 1.1 nm S of Thuong Thon	on Route 1A.		
DESCRIPTION:		•	
LENGTH	MATERIAL Wood and	concrete	25
WIDTH	NO. OF SPANS 6		20
Deck	LENGTH OF EACH SPAN		25
pecv	· L		
STATUS:			
Bridge repaired with the exce	eption of the decking o	on 1 span.	
COMPENSATIVE ACTION:			
NA			
			25
